OPERATING EXPERIENCE SUMMARY

Office of Nuclear and Facility Safety

February 1 – February 14, 2000

Summary 2000-03

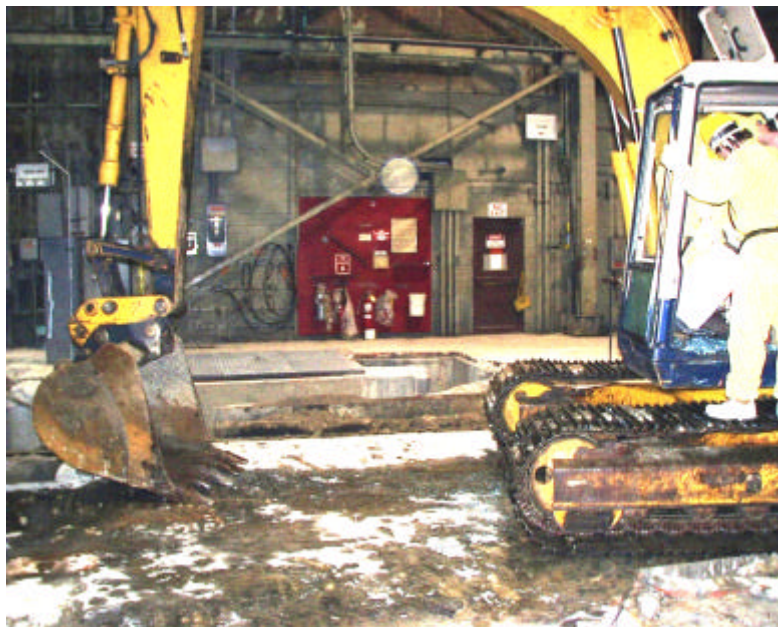
Figure 1-1. Trackhoe used to backfill press pits

On February 1, 2000, at the Ashtabula Environmental Management Project Site, a contractor trackhoe operator was nearly struck by a broken bucket extension when he attempted to break-up a reinforced concrete pier using the trackhoe bucket. The projectile smashed the trackhoe window and scattered broken glass throughout the cab interior, damaging a foot pedal controller. Facility management instructed the operator to stop work immediately and shut down his equipment. The trackhoe operator removed the broken glass from the trackhoe after safety personnel responded to the area and reviewed the incident. Facility management instructed the contractor to complete the job with a portable concrete saw and a jackhammer. There were no injuries associated with this event. Improper use of equipment can lead to serious injury. (ORPS Report OH-AB-RMI-RMIDP-2000-0002)

The extrusion plant houses press pits which were used to manufacture uranium billets. Facility management wanted to create additional floor space in the plant by backfilling the press pits with concrete to level the floor. Investigators determined that the technical specification and work request written for the backfilling procedure did not include steps for hammering concrete obstructions with a trackhoe bucket. Refer to Figure 1-1 for an overall view of the trackhoe and bucket. They determined that the trackhoe manufacturer designed the bucket teeth extensions according to industrial equipment standards and did not intend the bucket to be used as a substitute for a jackhammer. Refer to Figure 1-2 for details of the damage and the remaining tooth extensions. Investigators determined that the operator discovered the concrete pier obstruction after he started the job and did not follow procedure when he used the fully extended trackhoe arm and bucket to demolish the pier. Investigators also determined that site procedure dictates the use of a jackhammer or concrete saw to complete this type of job.

Personnel at DOE facilities should have a continually questioning attitude toward safety issues. Each individual is ultimately responsible for complying with rules to ensure personal safety. Facility managers should communicate the idea that safety is of prime importance and all personnel must be committed to excellence and professionalism. Instructions to workers should emphasize changes in work methods or equipment, or any other deviation from an approved work plan, can introduce unforeseen hazards. Changes to approved work methods, equipment, and plans must receive the same hazard analysis, review, and approval as the original work plan. Any change should entail a work stoppage combined with a thorough review of the potential hazards associated with the change.

Personnel at DOE facilities are required to follow established work control plans without exception. Facility managers, work planners, and subcontractor supervisors should review the following references, which provide guidance and good practices for implementing work control plans.

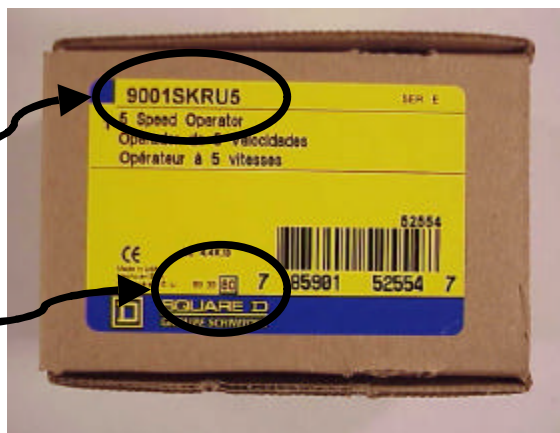
Product Carton Label

- 1) Check Product Carton for Class 9001 Type SKRU2, SKRU3, SKRU4, or SKRU5. All other types are not affected by this notice.
- 2) Date Codes 9901, 9902, 9903, etc.... through 9935 should be returned. The date code is located to the left of the box with 80 in it, as shown.

- 1.** Determine the date of manufacturing for your Class 9001 Type SKRU2, 3, 4, or 5 product by checking the date code located on the carton. (See Attachment A, PRODUCT IDENTIFICATION INSTRUCTIONS) Date codes of 9901, 9902, 9903, through 9940 must be returned.
- 2.** If you identify products with these date codes, make arrangements for immediate replacement of the operators by ordering a new device from your local Square D Distributor. You will obtain full credit for the replacement operators by returning the old device to you local distributor. Your distributor will return these devices to Square D Company.

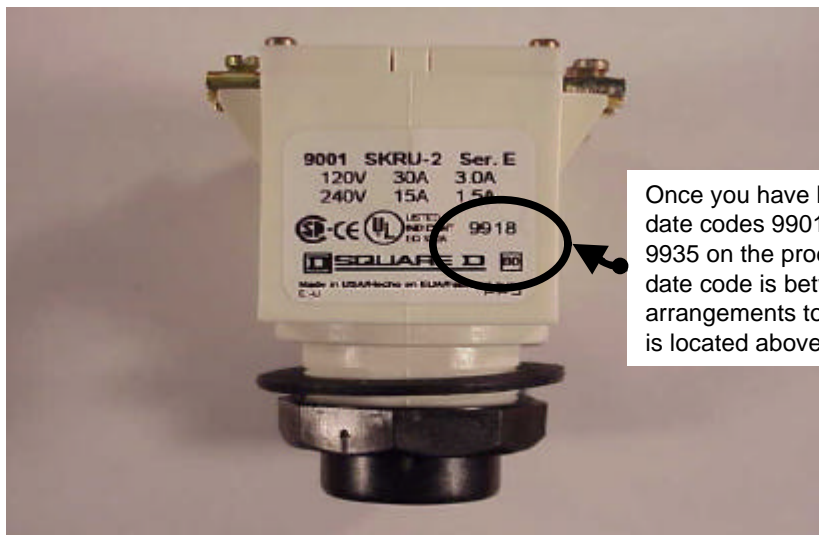
Once you have located the device, check for date codes 9901, 9902, 9903, etc.... through 9935 on the product nameplate as shown. If the date code is between 9901 - 9935, make arrangements to replace the device. Date code is located above the box with 80 in it, as shown.

If you identify products with date codes of 9901, 9902, 9903, through 9940, make arrangements for immediate replacement of the operators. Please complete the attached CUSTOMER INFORMATION FORM (Attachment B). List the Type Number and Quantity of products identified. Fax the completed form to (828) 255-1576 or mail it direct to:
